OLYMPUS
35 DC
REPAIR MANUAL

OLYMPUS OPTICAL CO., LTD. TOKYO, JAPAN

35 DC

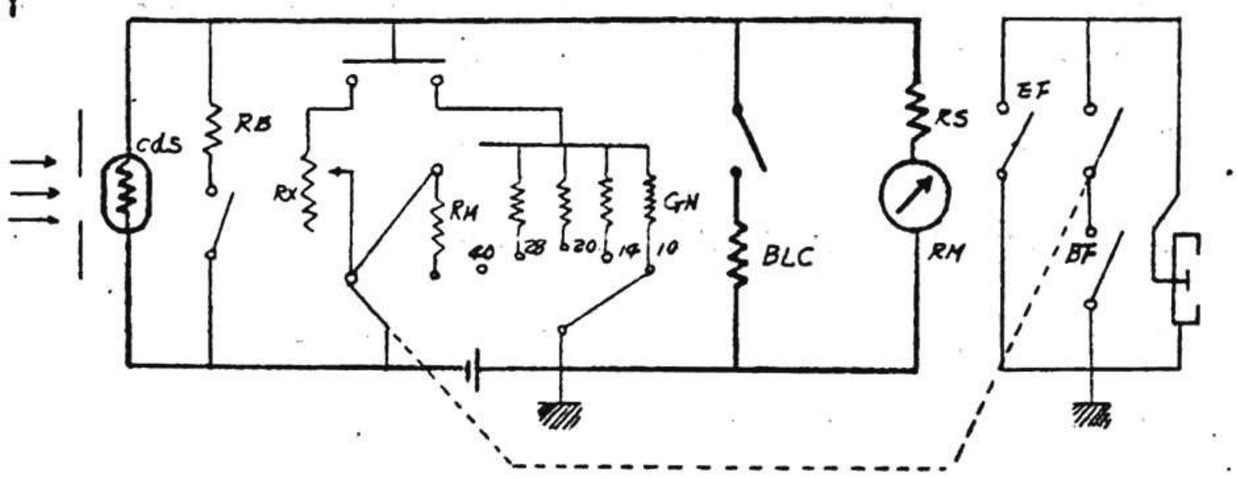
Cause	Remedy	Confirmation
1) Defective wiring and soldering	Correct the defective part. EE Circuit and BLC Circuit

Confirm on the EE and BLC circuit diagrams.
2) Short-circuit of the MX circuit board blue lead wire soldering portion and the meter body	Correct the soldered portion. The lead wire connecting directions are as illustrated below. Soldering is to be done taking care not to make excessive solder deposition. MX Circuit Board

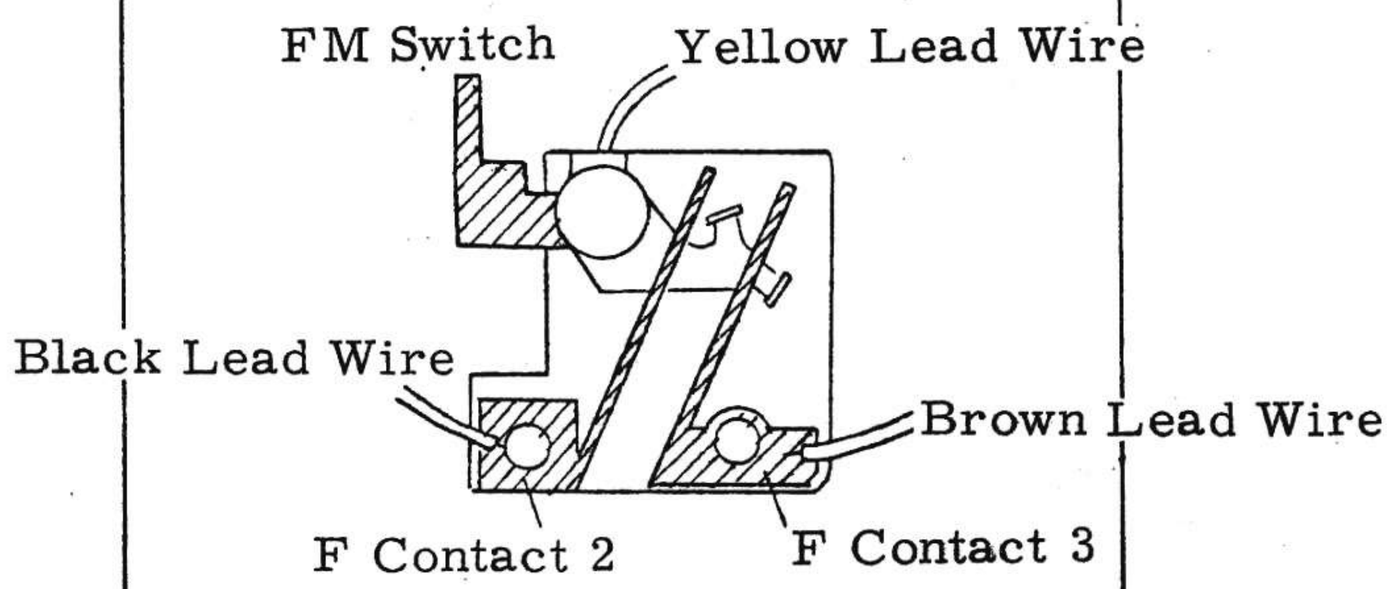
Cause	Remedy	Confirmation
1) FM switch is ON	Correct the contact in the direction to be set to OFF by means of a pincette. The lead wire soldering directions are as illustrated below. Soldering is to be done taking care not to make excessive solder deposition. FM Circuit Board

Confirm with a tester for the conduction of the brown lead wire, the black lead wire and the yellow lead wire of the FM switch. Normal if no conduction is detected.

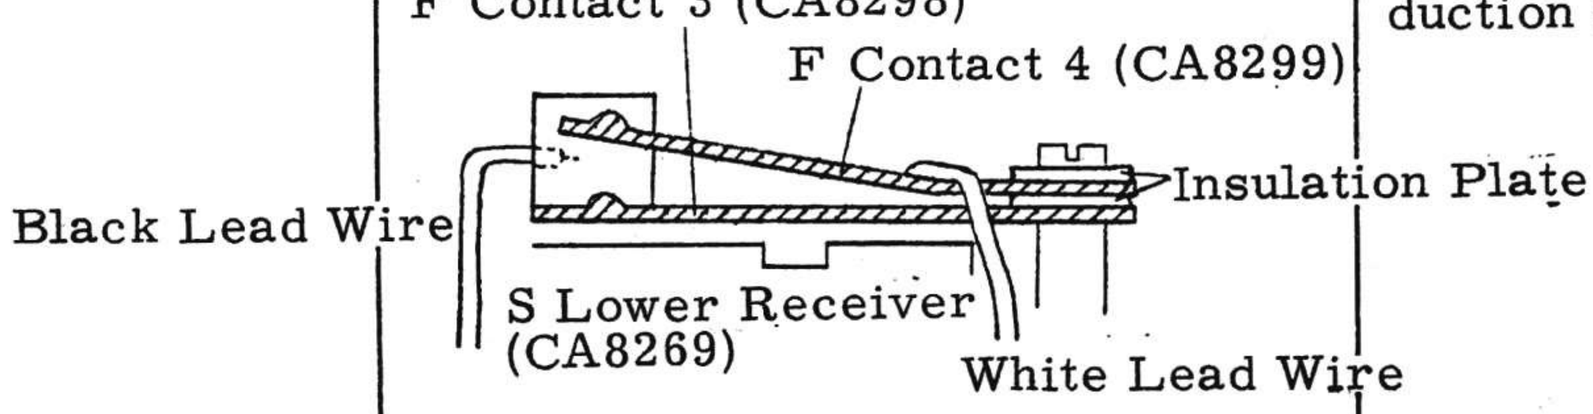
Cause	Remedy	Confirmation
3) F contact 3 and 4 contacted	Correct the shapes of the F contacts 3 (CA8298) and 4 (CA8299) by means of a pincette.

Confirm by a tester for the conduction of the F contacts 3 and 4. Normal if no conduction is detected.

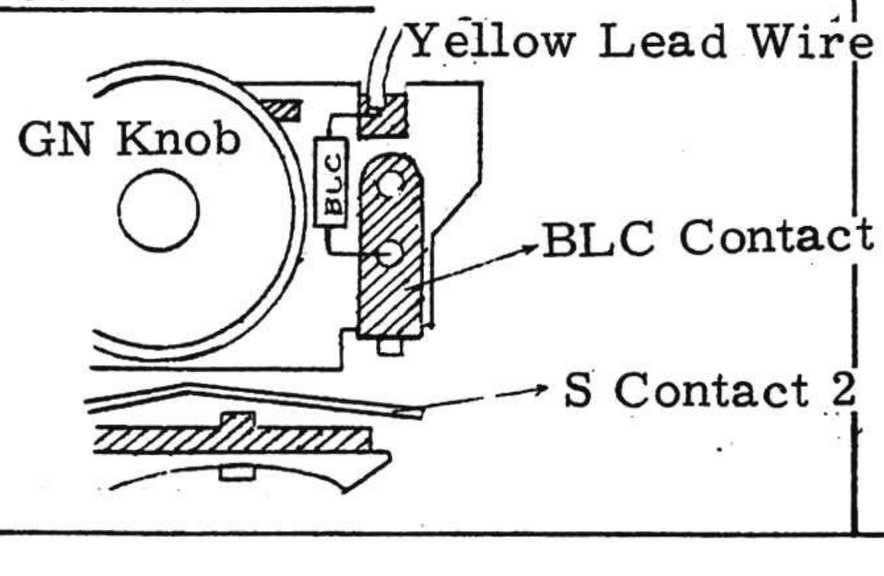
Cause	Remedy	Confirmation
1) Contact failure of S contact 2 and GN circuit board BLC contact	Clean the contacting portion of the S contact and GN circuit board BLC contact, correct the spring pressure of the S contact 2 in the pressure increasing direction by means of a pincette.	The exposure should be changed by about 1.5EV when the BLC button is depressed.
2) Defective soldering of BLC	Do the soldering again.	Same as the above.
3) Defective BLC	Replace it. GN Circuit Board

Same as the above BLC is 7 ~ 8 KΩ.

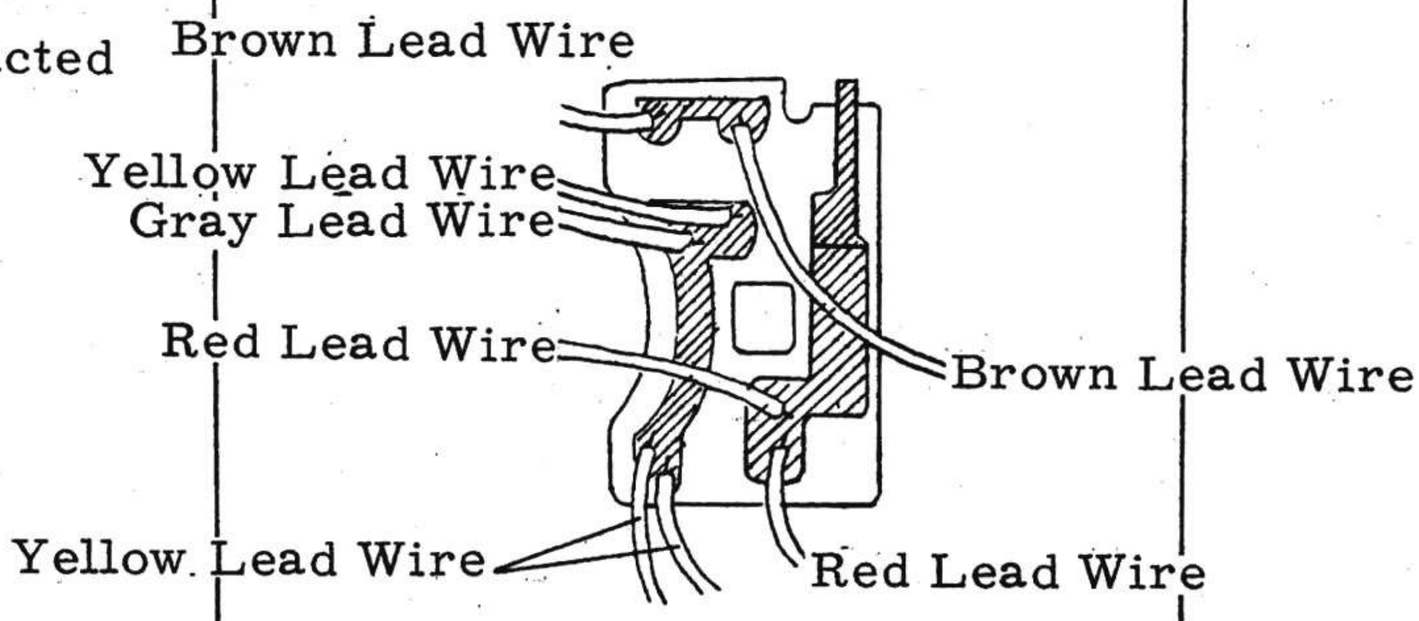
Cause	Remedy	Confirmation
1) F circuit board brown lead wire soldering portion and the upper plate contacted	Correct the soldered portion. The lead wire connecting directions are as illustrated below. Soldering is to be done taking care not to make excessive solder deposition. F Circuit Board

The shutter should be released when the FM switch is depressed with the GNO ring set to the maximum, the distance ring set to the closest and the CdS covered.

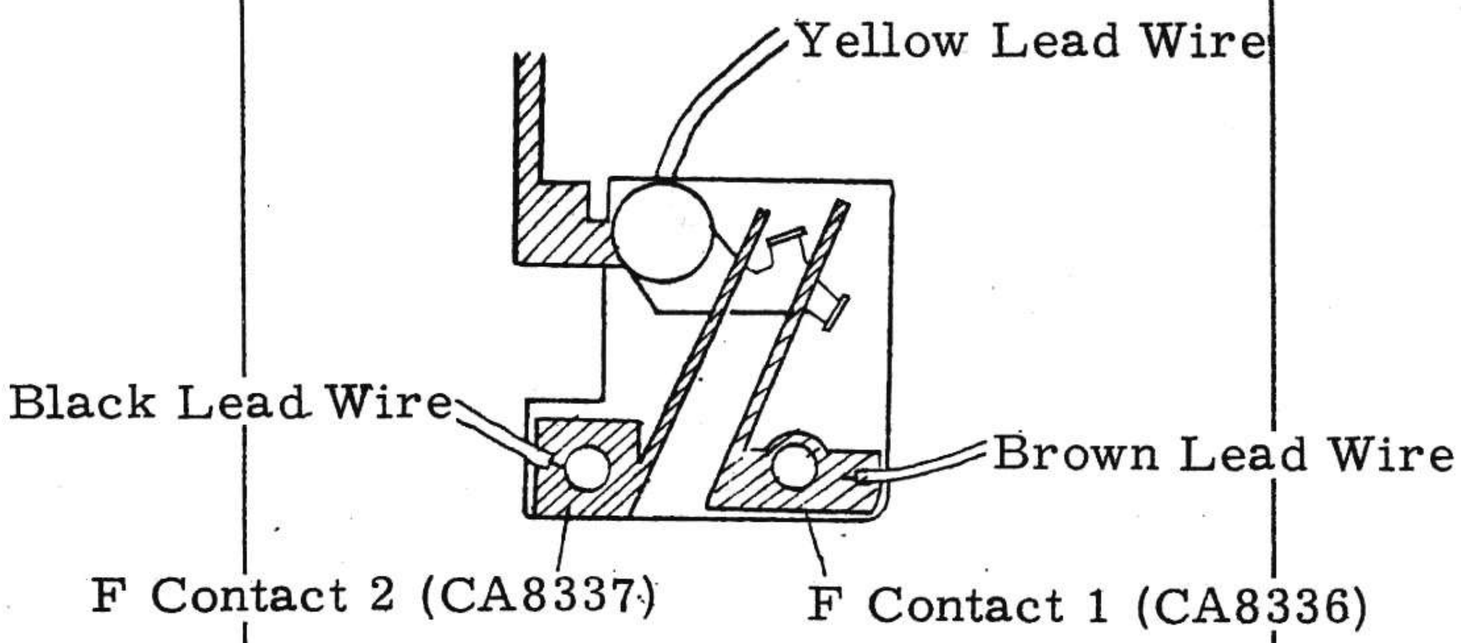
Cause	Remedy	Confirmation
2) Contact failure of FM switch and F contact	Clean the F contact portion, and correct the contact by means of a pincette. (Caution) Take care not to bend the contact excessively. If so, the switch is left closed.

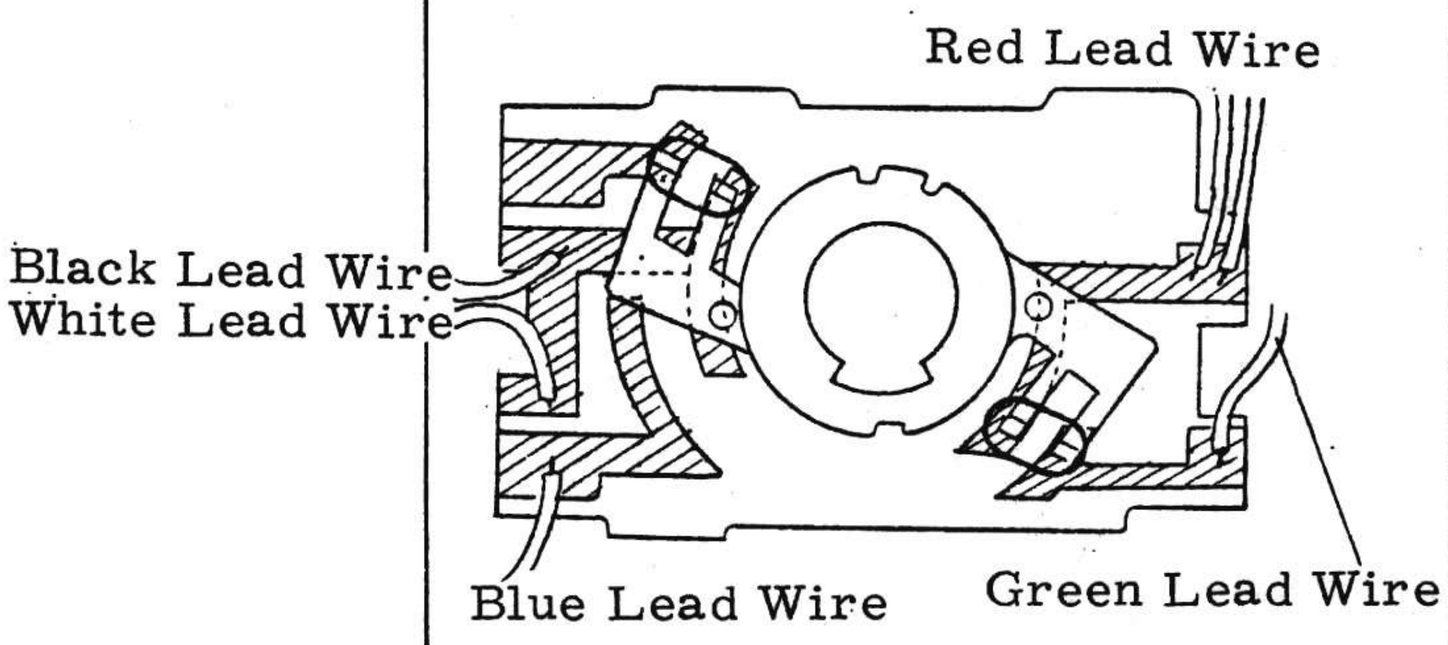
Same as the above.
3) Contact failure of MX contact and MX circuit board	When they are not conductive, correct the MX contact by means of a pincette, clean the contacting portion of the MX contact and the MX circuit board and apply thin coat of conductive agent (Electro-lub, Echo, etc).

Confirm with a tester for the conduction of the white and black lead wire soldered portions and the blue lead wire soldered portion of the MX circuit board when the MX lever is set to the EF (ϟ) mode. Normal if the conduction is detected. Confirm with a tester for the conduction of the yellow and red lead wire soldered

Cause	Remedy	Confirmation
		portions and the green lead wire soldered portion of the MX circuit board when the MX lever is set to the BF ( ) mode. Normal if the conduction is detected.
4) Defective meter	Replace the meter.

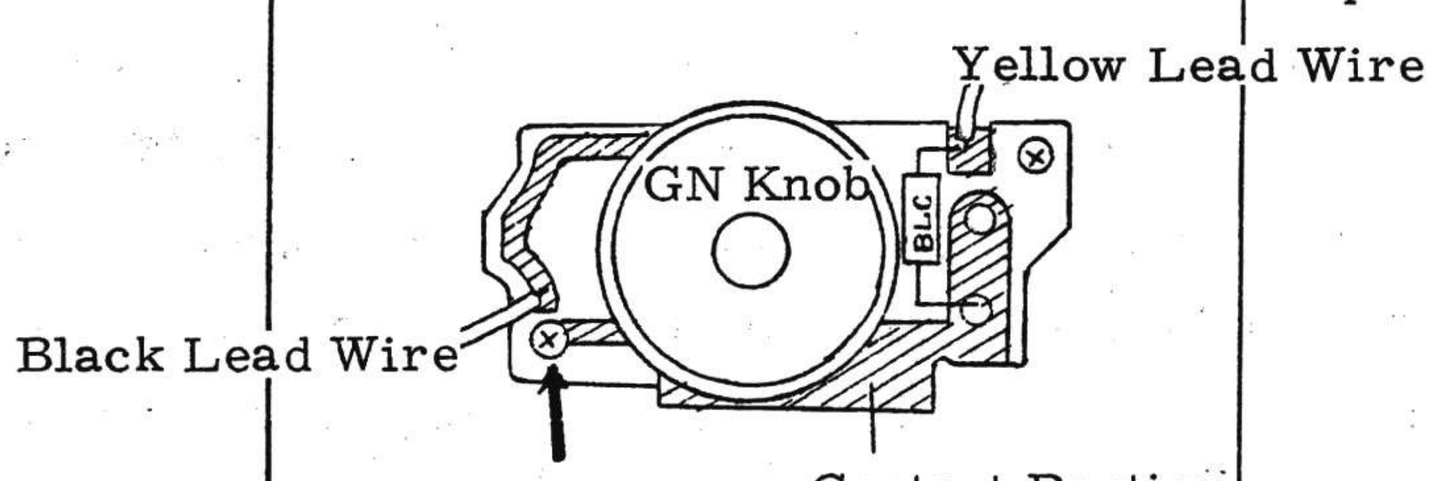
GN Circuit Board .

Cause	Remedy	Confirmation
1) Defective body grounding of GN circuit board	Clean the contacting portion of the GN circuit board and the left side fixing screw (arrow marked in the illustration below), and then tighten it again completely. If the conduction is still incomplete even after the sufficient tightening of the screw, replace the GN circuit board.	Normal if the conduction is detected when confirming with a tester for the conduction of the black lead wire soldered portion of the GN circuit board and the body with the FM switch depressed.

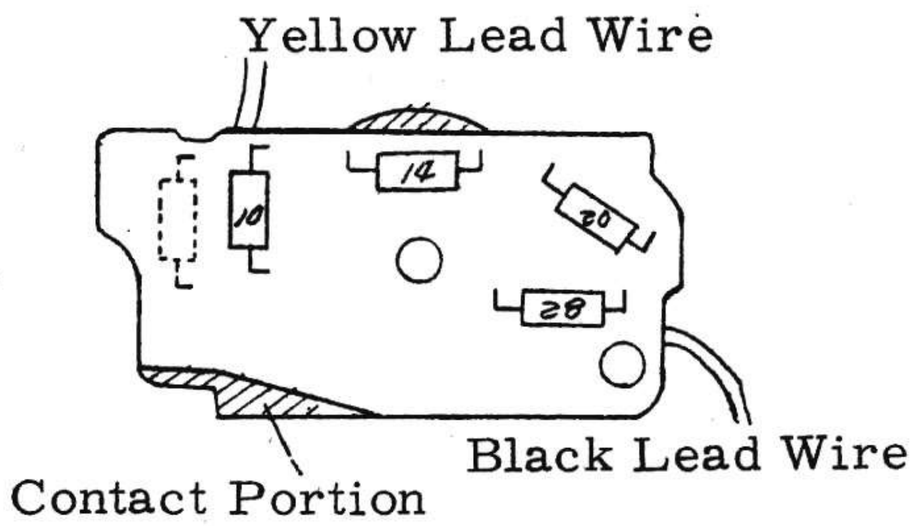
<table>
<tr><th>Cause</th><th>Remedy</th><th>Confirmation</th></tr>
<tr><td>2) Contact failure of GN circuit board and slide contact</td><td>Correct the slide contact in the contact pressure increasing direction by means of a pincette, clean the GN circuit board and the sliding portion of the slide contact, and apply thin coat of conductive agent.</td><td>Same as the above.</td></tr>
<tr><td>3) Defective resistor of GN circuit board</td><td>Replace the defective resistor.
<u>GN Circuit Board Back Surface</u>

</td><td>Confirm the change in the resistance value by rotating the GN knob while applying the tester probes to the black lead wire soldered portion of the GN circuit board and the body. Take the following values as a reference for the resistance value change.
<table>
<tr><td>GNO</td><td>10</td><td>14</td><td>20</td><td>28</td><td>40</td></tr>
<tr><td>K Ω</td><td>1</td><td>1.8</td><td>4.5</td><td>12</td><td>∞</td></tr>

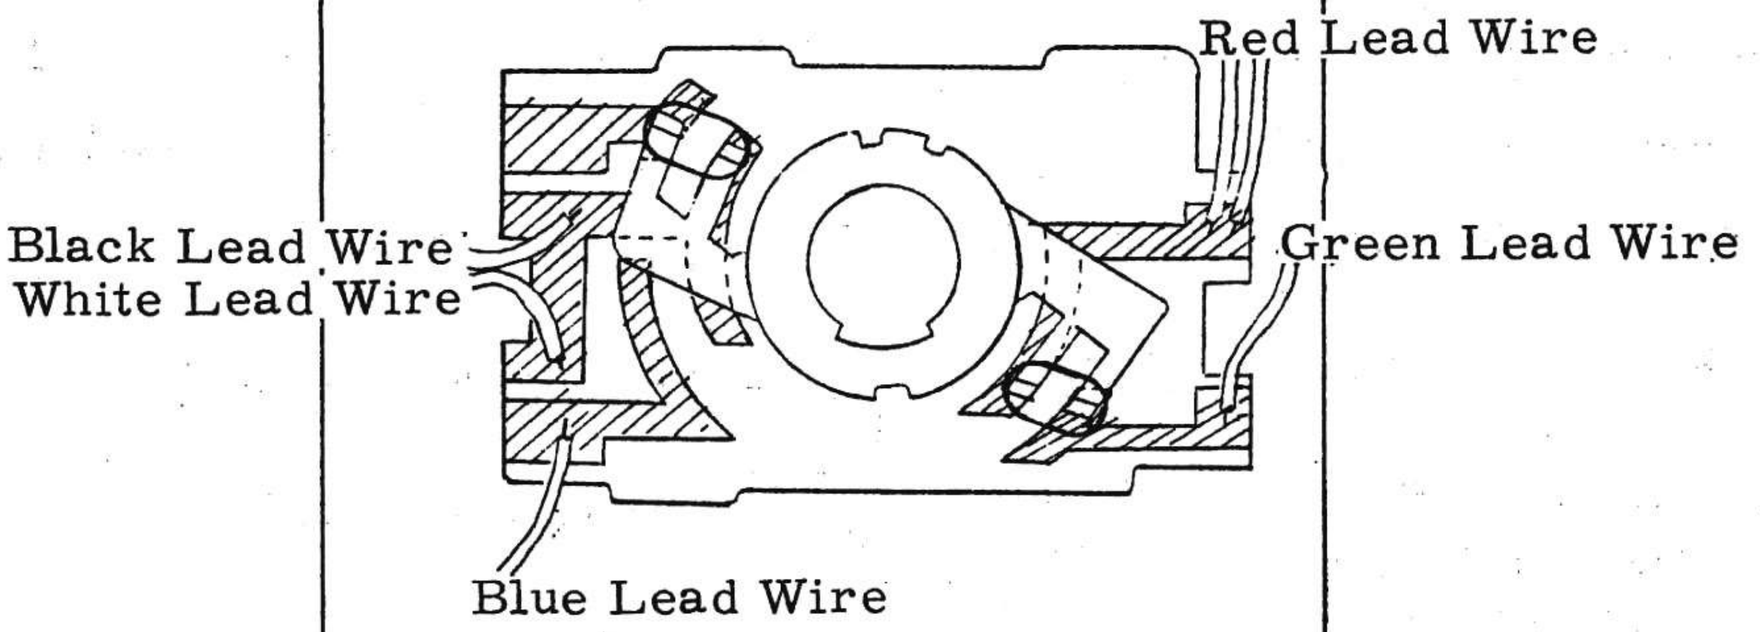
Cause	Remedy	Confirmation
1) Contact failure of MX circuit board and MX contact	When not conductive, correct the MX contact with a pincette, clean the contacting portion of the MX contact and the MX circuit board and apply thin coat of conductive agent.	Normal if the conduction is detected when checking with a tester for the conduction of the yellow and red lead wire soldered portions of the MX circuit board.

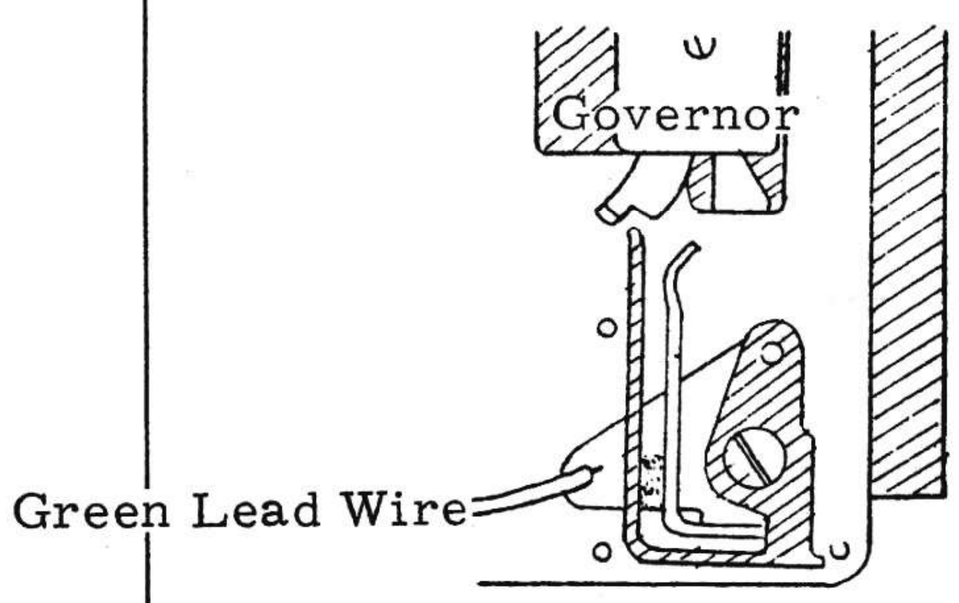
2) Contact failure of the shutter BF contact	When not conductive, clean the contacting portion of the BF contact and apply thin coat of conductive agent. (Caution) Take care not to bend the BF contact, because it affects the FM accuracy. BF Contact Contacting Portion

Normal if the conduction is detected across the green lead wire and the body when the shutter is released.

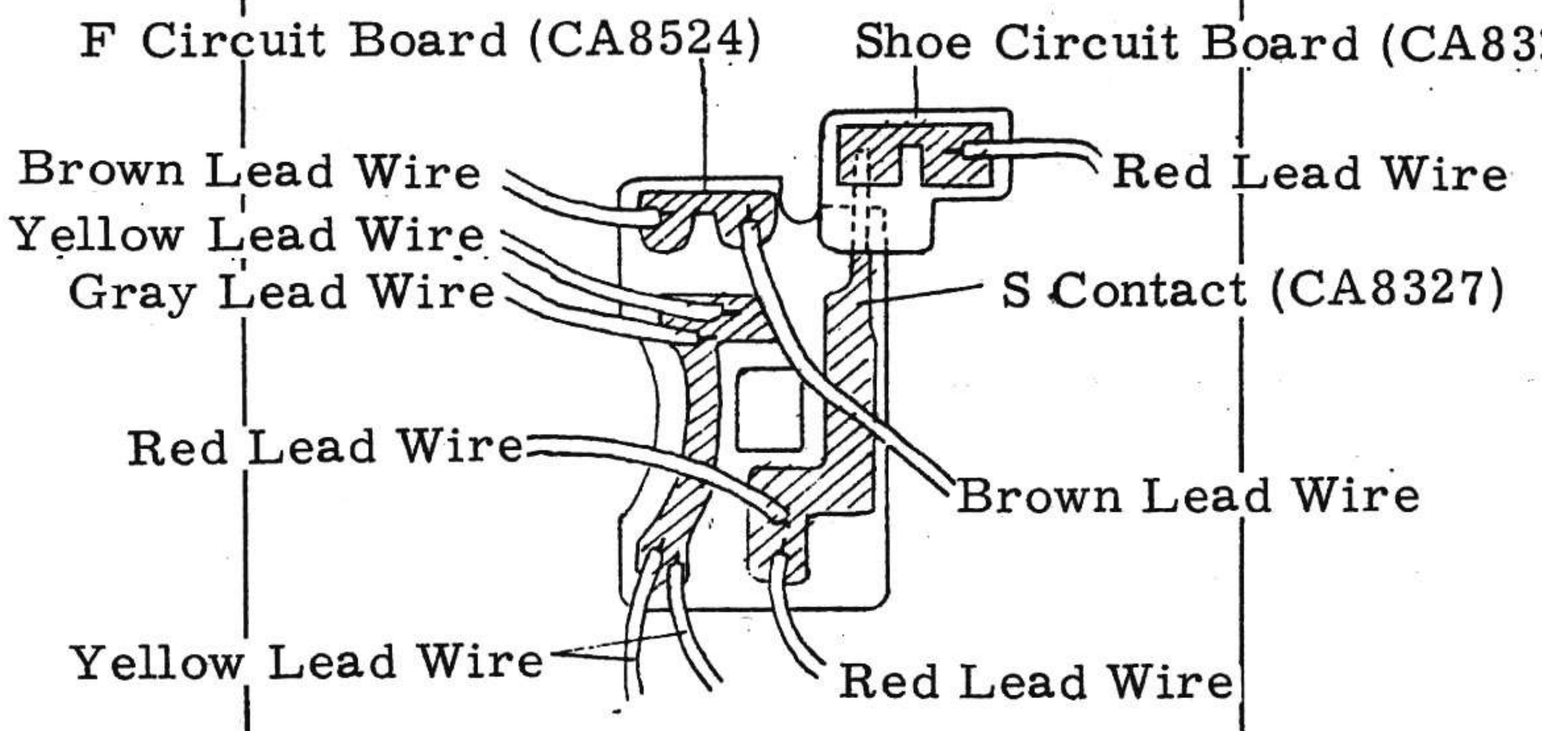
Cause	Remedy	Confirmation
1) Contact failure of	Correct the S contact in the spring pressure increasing direction by	When an electronic flash with a cordless

Cause	Remedy	Confirmation
shoe circuit board and S contact	means of a pincette, and then clean the contacting portion of the shoe circuit board and the S contact.	contact is mounted, it should emit flash light properly.

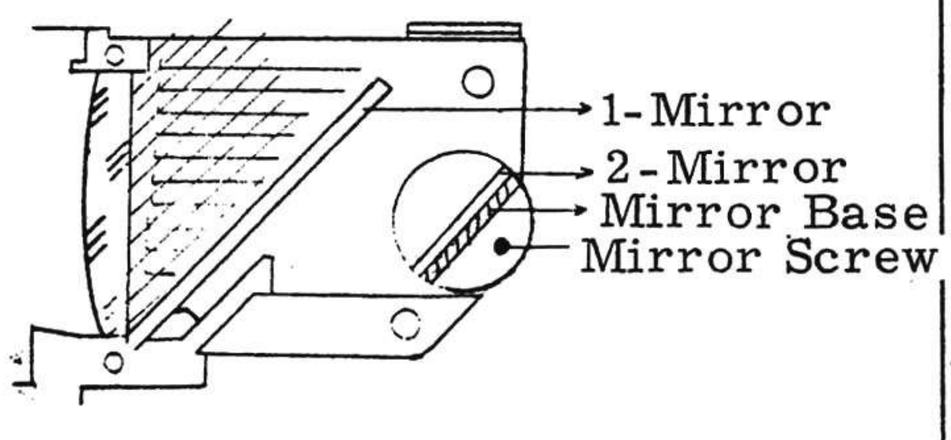
Cause	Remedy	Confirmation
1) Reflected image displaced upward	When the reflected image is displaced upward with respect to the transmitted image in viewing through the collimator with the mirror and lens cement not removed, turn the mirror screw (CA8097) clockwise.

Should not be displaced more than one line when checking by the collimator (f=600mm).
2) Reflected image displaced downward	Turn the mirror screw in the inverse direction to the above.	Same as the above.

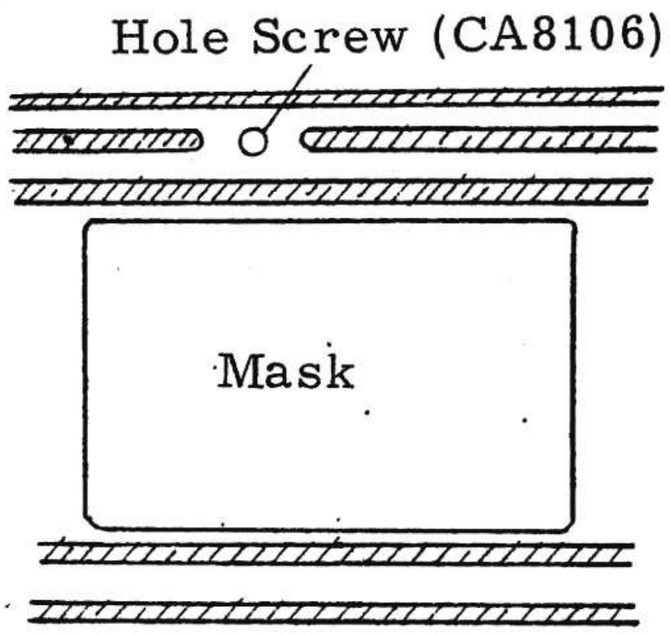
Cause	Remedy	Confirmation
1) Reflected image overrides	When the reflected image is displaced leftward against the transmitted image in viewing through the collimator with the mirror and lens cement not removed, turn the AD screw (CA8130) clockwise.

Cause	Remedy	Confirmation
	(Caution) The AD screw is the screw found inside when the hole screw (CA8106) on the main body rail surface is removed.

2) Reflection image short of superimposing position	Turn the AD screw in the inverse direction to the above.	Same as the above.

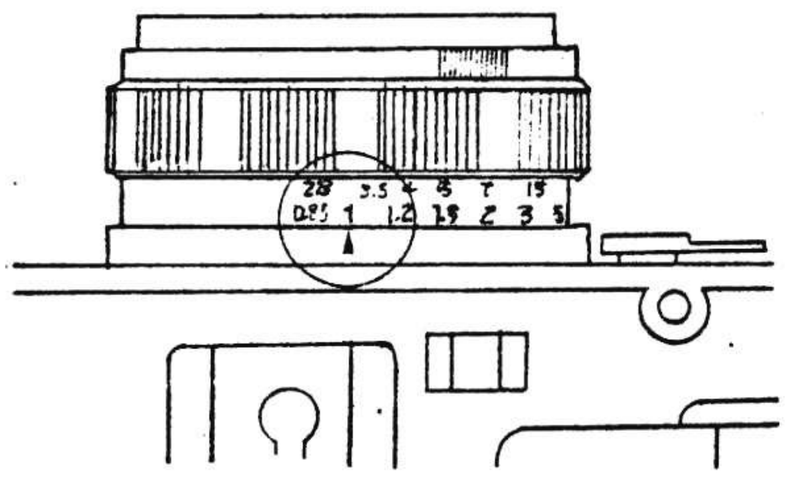
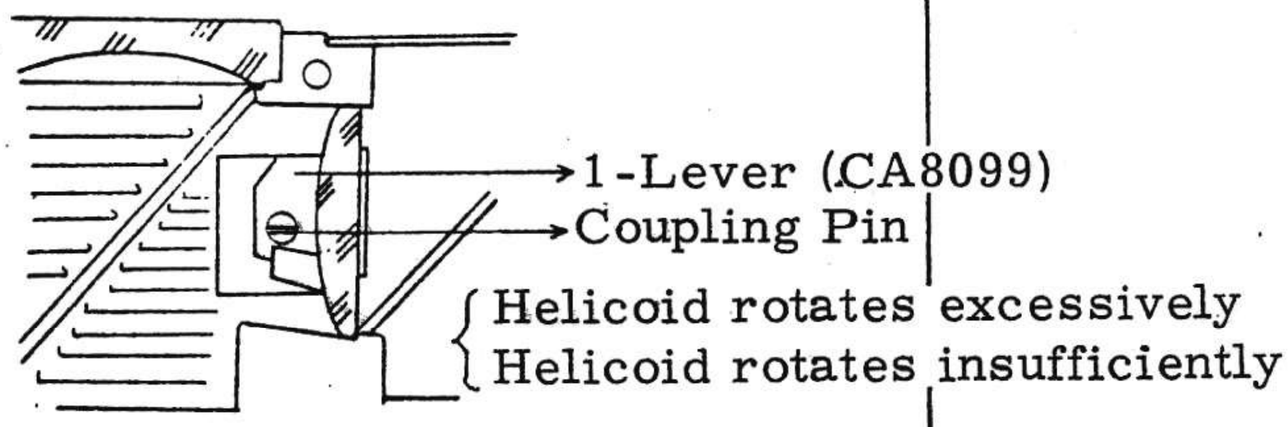
Cause	Remedy	Confirmation
1) Improper adjustment of close distance coupling	When the transmitted image and the reflected image are displaced at the close distance (1m) in the normal operation of the range finder, while no displacement at ∞, rotate the coupling pin (CA8104) of the 1-lever (CA8099) by the small extent for adjustment. At this time, if the rotary force of the coupling pin is extremely	At 1m $^{+0.03}_{\pm 0.05}$

Cause	Remedy	Confirmation
	weak, remove the 1-lever and caulk the pin once more. (1-lever rotary force: Less than 1.2kg/mm) o Helicoid rotates excessively ($\Delta 1 \infty$): Turn the coupling pin clockwise o Helicoid rotates insufficiently ($1 \Delta \infty$): Turn the coupling pin counter-clockwise.

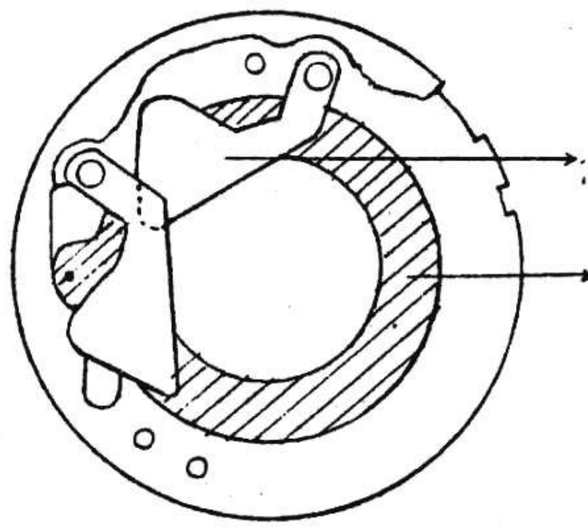
Cause	Remedy	Confirmation
1) Sector tenacious	Disassemble the shutter according to the disassembly procedure (Demounting of Shutter), and clean the lubricant exuding to the exposure blade (924-2031), external frame (924-0003), base plate (924-0001), ring base (924-2141) and ring (924-2019). The exposure blade mounting procedure is as shown in the illustration below.	Sector should surely operate.

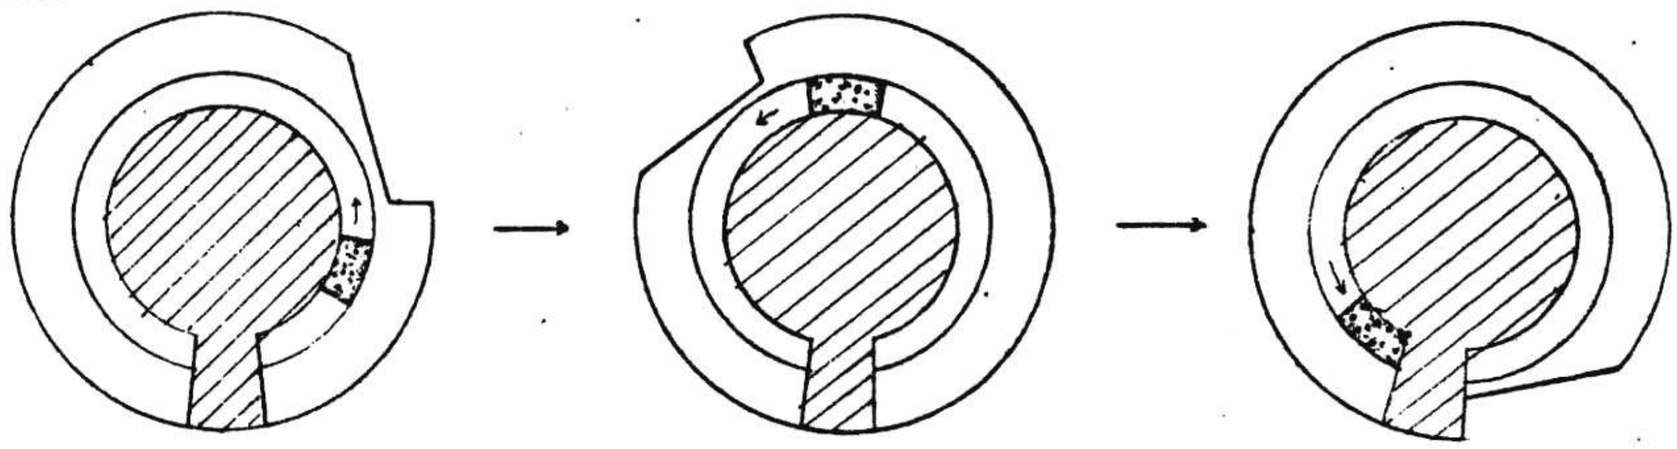
2. Electronic flash or bulb flashes upon winding

1) Contacted EE contact

When the EF contact is contacted in the cases other than the above illustration " 4 Release depressed", adjust the contact with a pincette so that it has slight clearence at the time of the above illustration 2 (Winding under proceeding).	When winding with the electronic flash clipped on, it should not flash.

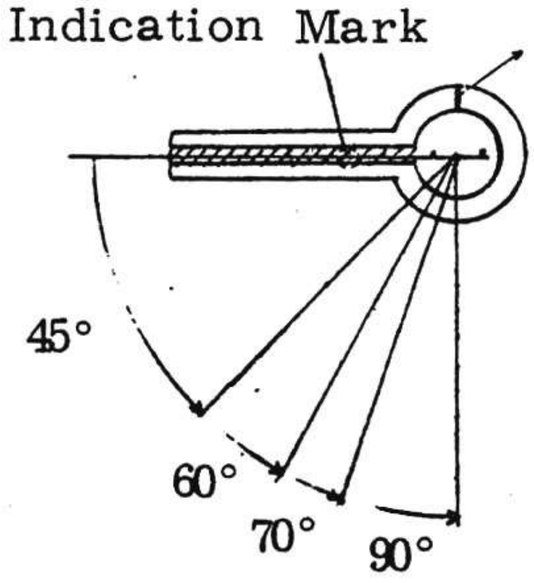
Self Lever Indication Mark

Upper Plate Indication Mark

0 - 45°	Set impossible
45° - 60°	Set possible The starting operation is effected, but the shutter is not released.
60° - 70°	Starting operation is not effected.
70° - 90°	Normal operation.

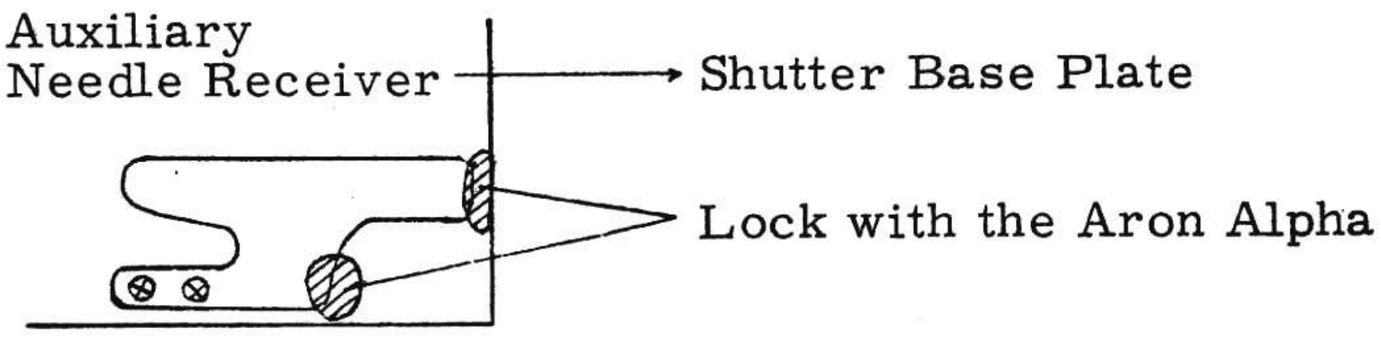
The high brightness plus or minus is to be adjusted by the needle receiver (924-0628) (in case of the high brightness plus, the needle receiver is lifted in its left side viewed from the front). After the adjustment, take care not to project the needle receiver exceeding the shutter base plate. If the needle receiver is projected, it will hit against the base plate (CA8205) causing the change in the EE accuracy.

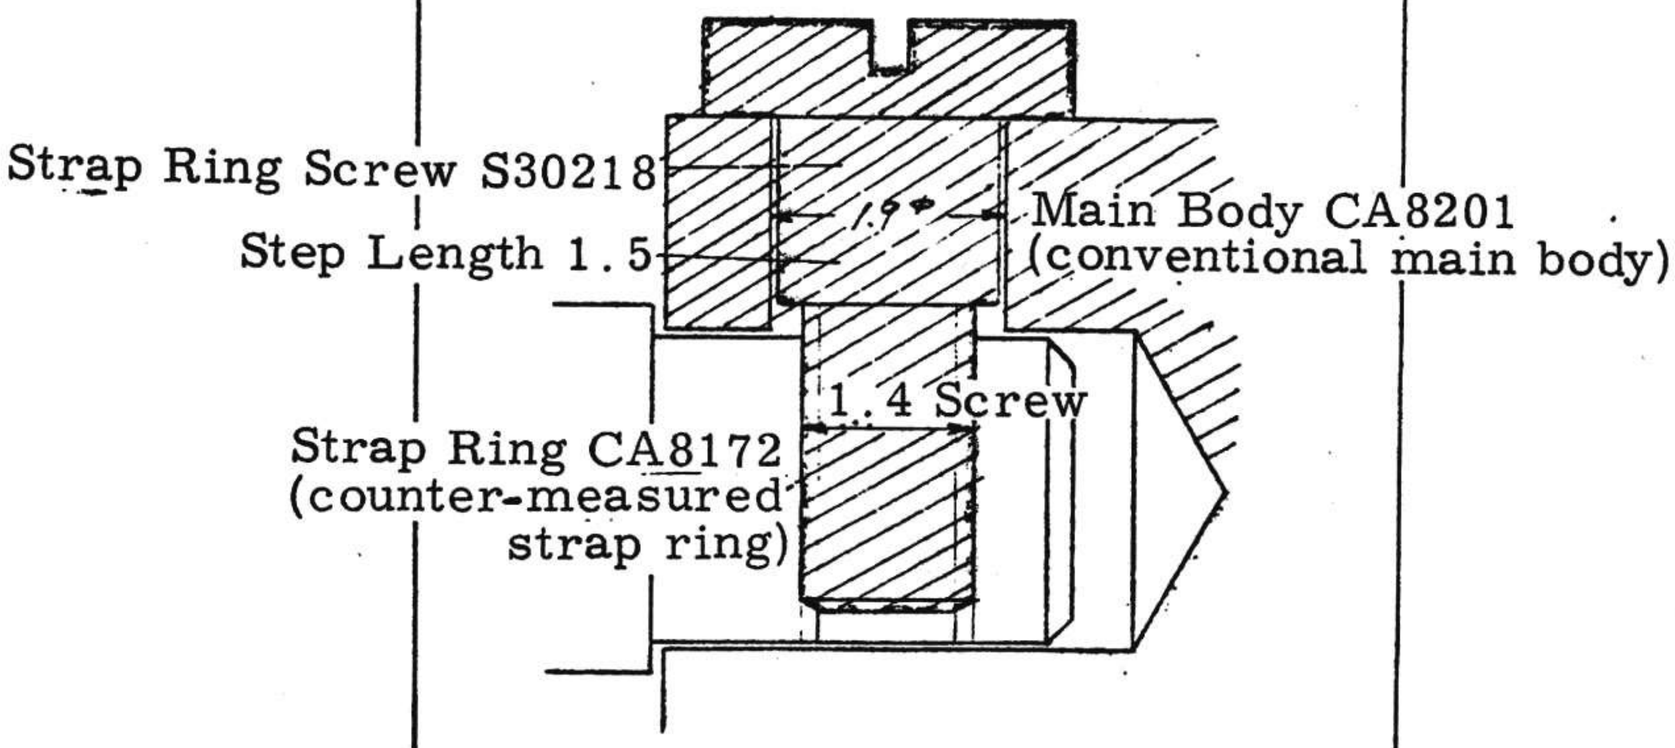
13. Strap ring breakage

Cause	Remedy	Confirmation
1) Strap ring breakage (easy-to-break due to 1.7ϕ screw hole in the strap ring of 2.6ϕ)	Although the main body (CA8361), the strap ring (CA8172) and PUK1.4x4SO (strap ring screw) are described in PR and RM, the main body (CA8201), the strap ring (CA8011) and PUK1.7x4SO (strap ring screw) are actually used as in the LEE-11. This strap ring is easy-to-break because of the left described reason. When the strap ring is broken, repair it in the following manner. o Replace the broken ring by the strap ring CA8172. o Mount the ring on the main body with the strap ring screw while leaving the main body as it is.

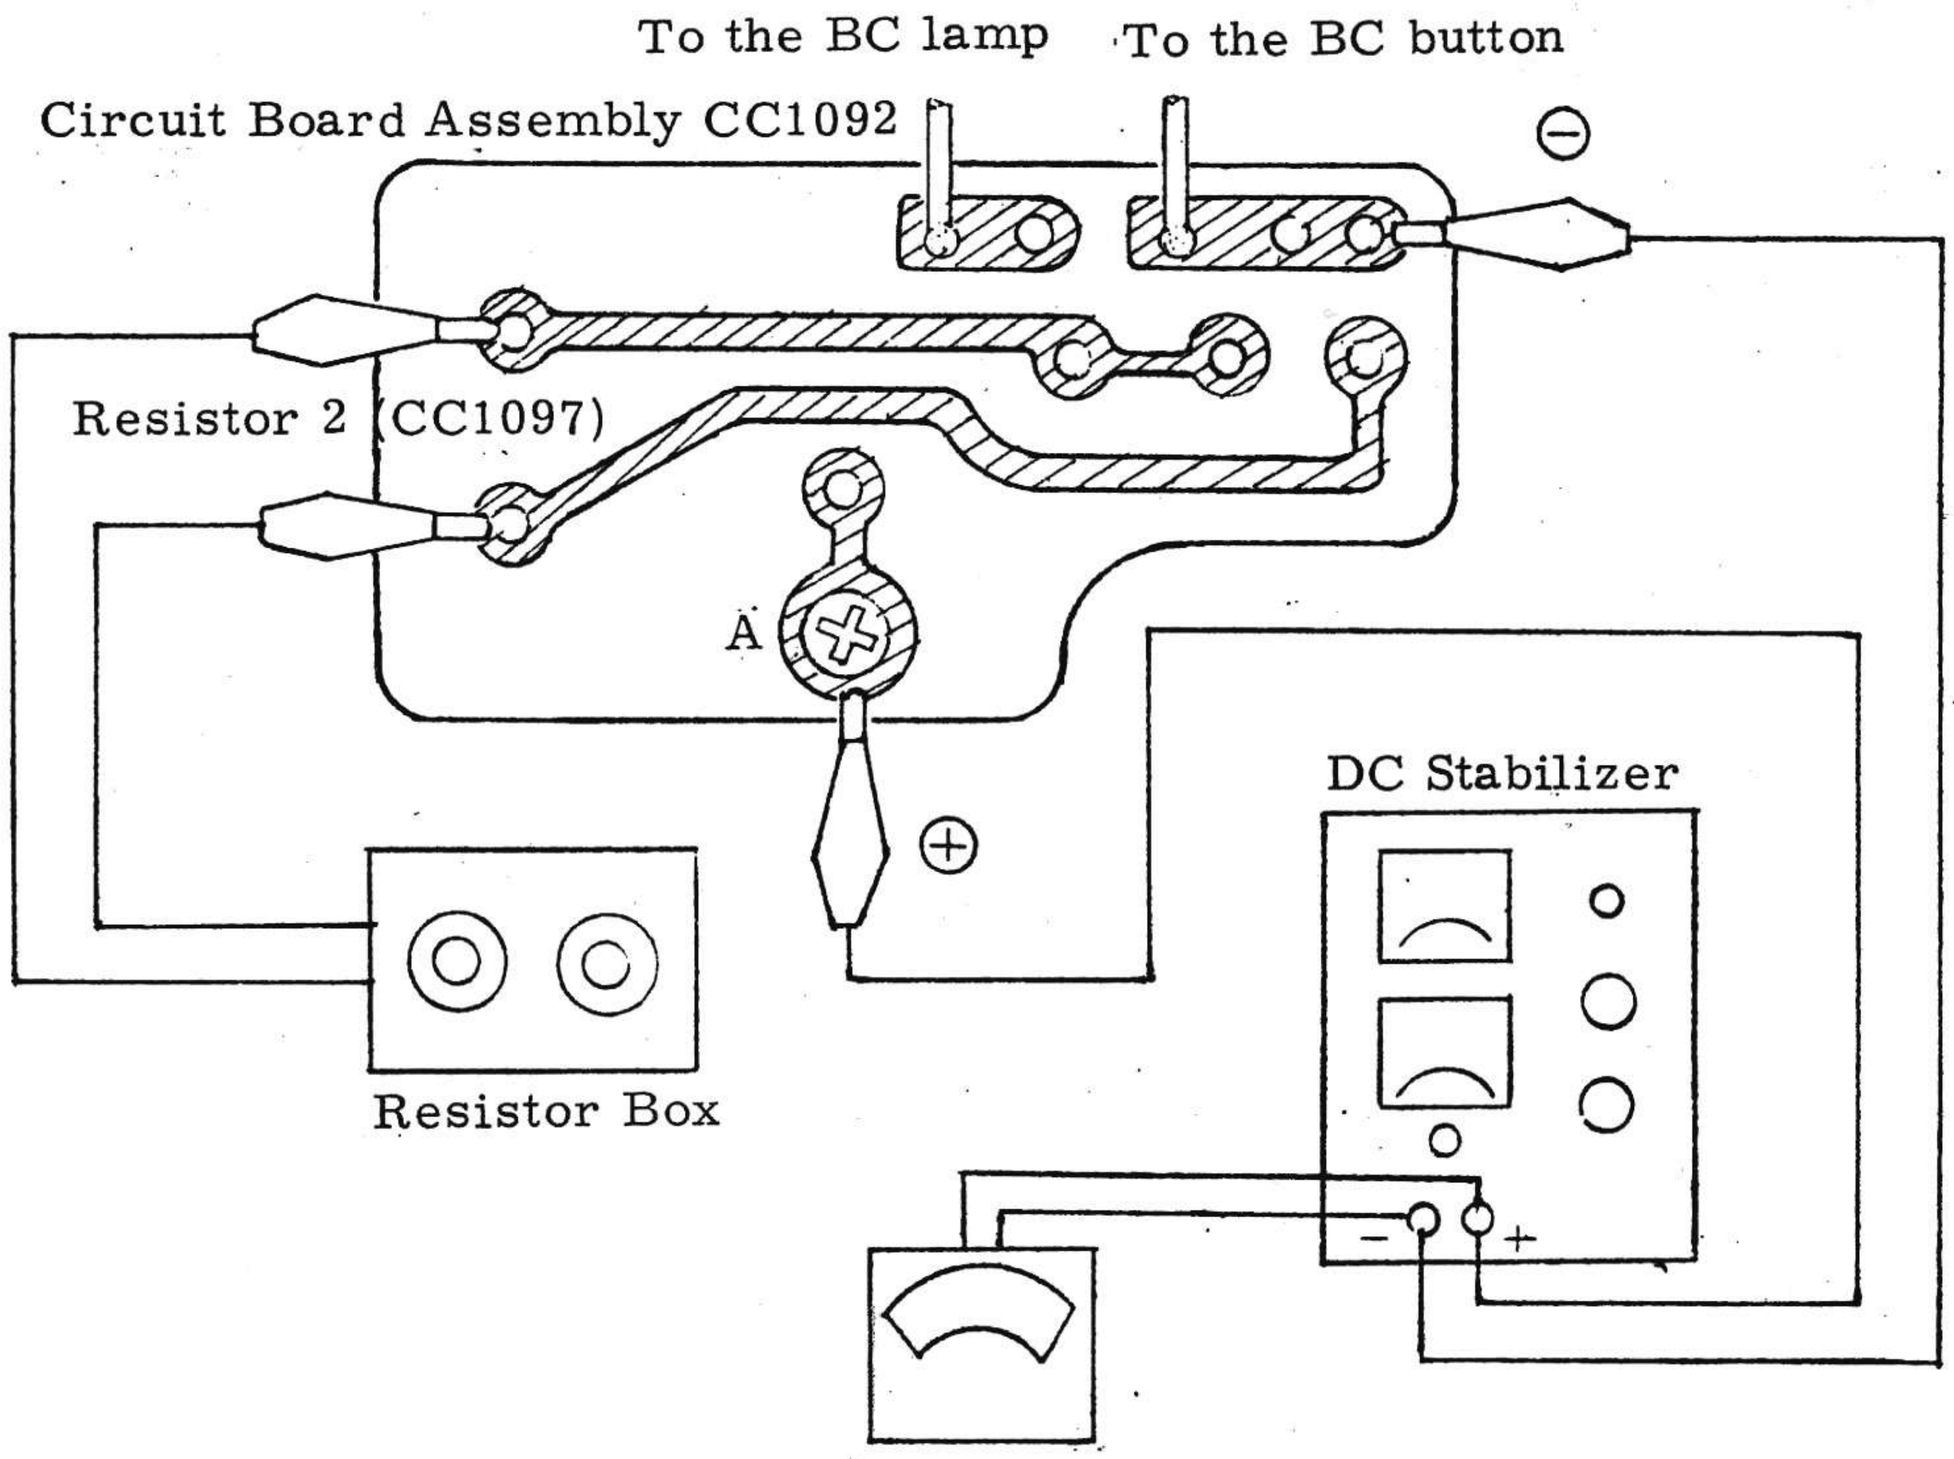
Fig. 1

2. Connection Diagram upon the Adjustment (The following illustration indicates the connection diagram with the circuit board CC1092 not removed from the body.)

The adjustment is done by varying the value of the resistor 2 (CC1097) (see Figs. 1 and 2). The resistor 2 (CC1097) is replaceable by a resistor for the EE adjustment, so use it for the substitution.

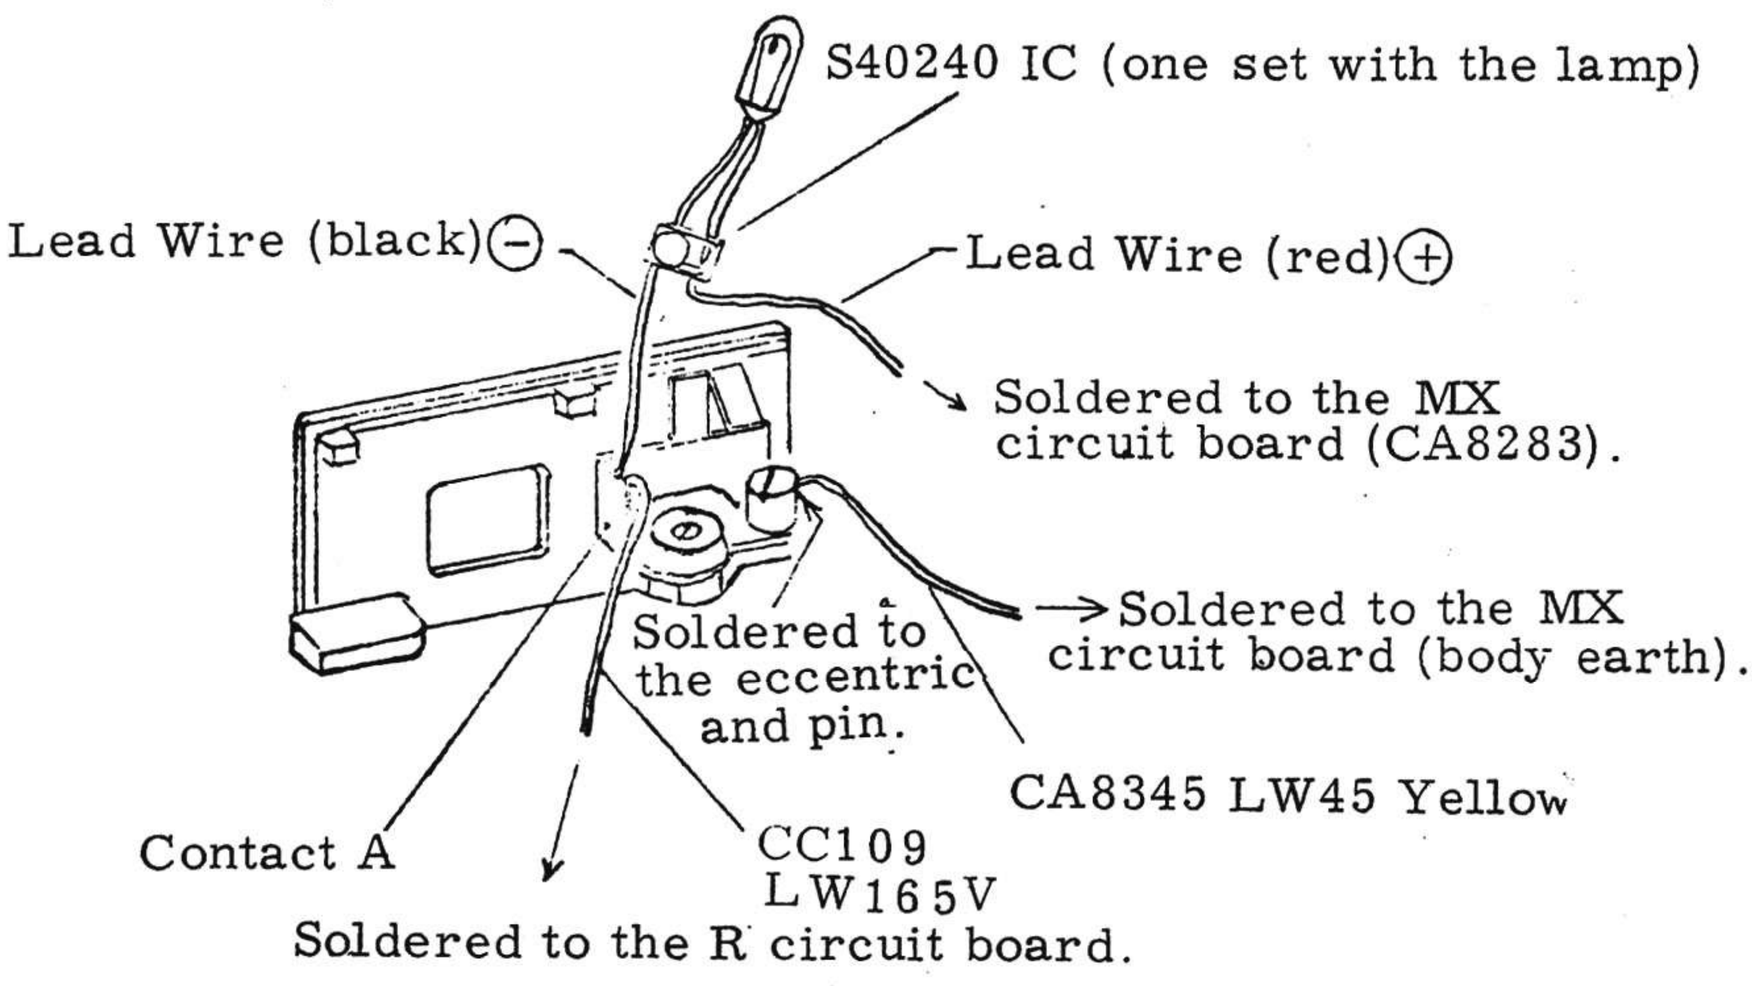
In case of the lamp blown off, replace it together with the IC and make the wiring as follow.

S40240 IC (one set with the lamp)
Lead Wire (black)⊖
Lead Wire (red)⊕
Soldered to the MX circuit board (CA8283).
Soldered to the eccentric and pin.
→Soldered to the MX circuit board (body earth).
CA8345 LW45 Yellow
Contact A
CC109 LW165V
Soldered to the R circuit board.
